THE EFFECTIVENESS OF THE DEBRIS BARRIER AT THE INTERSECTION OF ESLAVA CREEK AND WOODCOCK BRANCH

Sean M. Huber, Department of Earth Sciences, University of South Alabama, Mobile, AL 36688. E-mail: smh314@jaguar1.usouthal.edu.

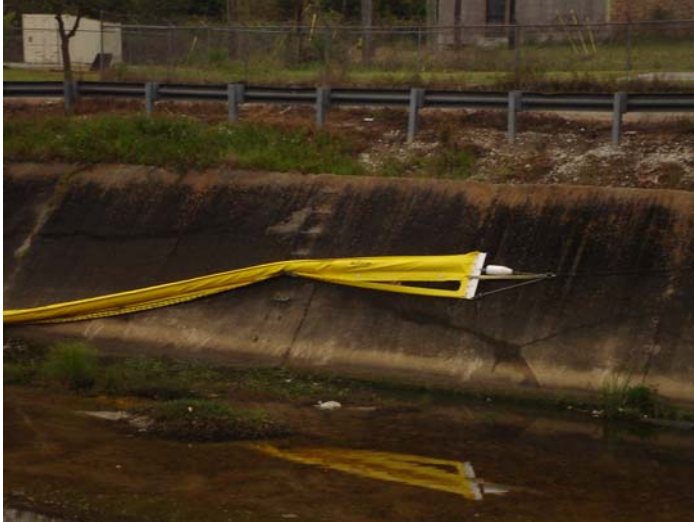
Image 1 to the left shows the Eslava Creek extension of the debris barrier. The steel cable anchor extending above the channel is seen to the right edge of the photo.

The first visit to the debris barrier behind Food World on US-90 (Government Street) at the confluence of Eslava Creek and Woodcock Branch was on March 31, 2008. In Figure 2, many key observations of the barrier are shown. The debris barrier's construction consists of a long yellow, floating boom that stretches like a horseshoe

across the channel. Both sides of the debris barrier have steel cables tied to an anchor. The Eslava Creek side of the channel has a long steel cable that is anchored above the concrete channel. Conversely, the Woodcock Branch side of the debris barrier has a short steel cable that is anchored into the concrete channel about midway between the streambed and shore. The yellow boom floats about six inches tall above the water. Extending below is a section about two feet deep with a net built in that is about one foot wide. These dimensions are visual estimates made from the riverbank.

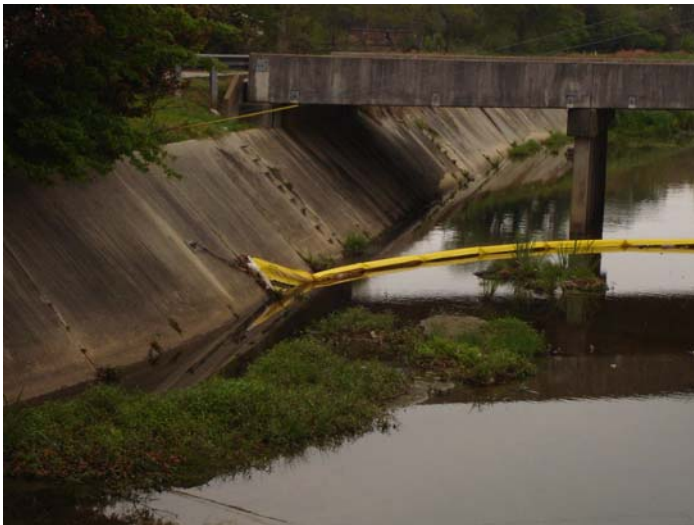
Image 2 to the left shows the short cable anchored at the middle of the concrete channel on the Woodcock Branch side of the debris barrier.

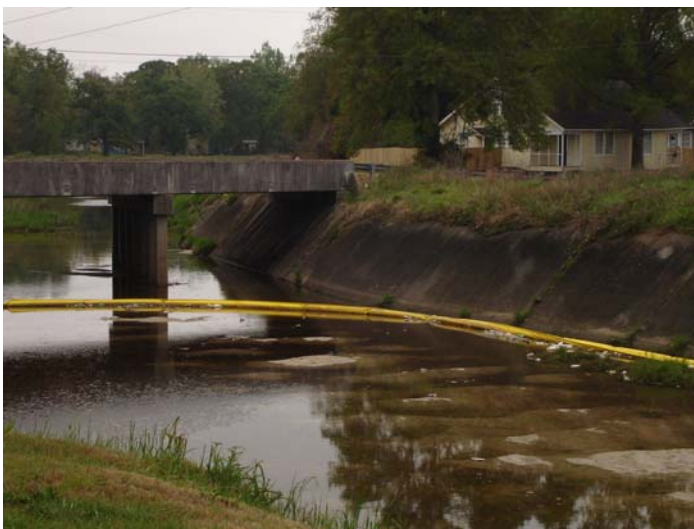
Figure 2

Image 3 is a wide range view of the debris barrier. Some debris is seen along the barrier, and north of the barrier resting on stream sediment.

Two days before the first visit, Mobile received a light rain that most likely did not affect the debris barrier's surroundings except to add debris to the area. The Woodcock Branch side is a concrete channel and has less sediment near the barrier than the Eslava side. In the Eslava Creek, the bank has more sediment and plenty of tall grasses, which provide stopping points for debris. In fact, the Eslava creek side of the confluence had plenty of Styrofoam cups, and bags caught along the lower banks. The Woodcock Branch side has larger items such as boxes caught on the sediments. The barrier itself had some trash caught along the floating boom of the barrier on the surface of the water (Figure 2). The majority of the trash appeared to be cups, chip bags, fast food wrappers, plastics of different types, and athletic balls.

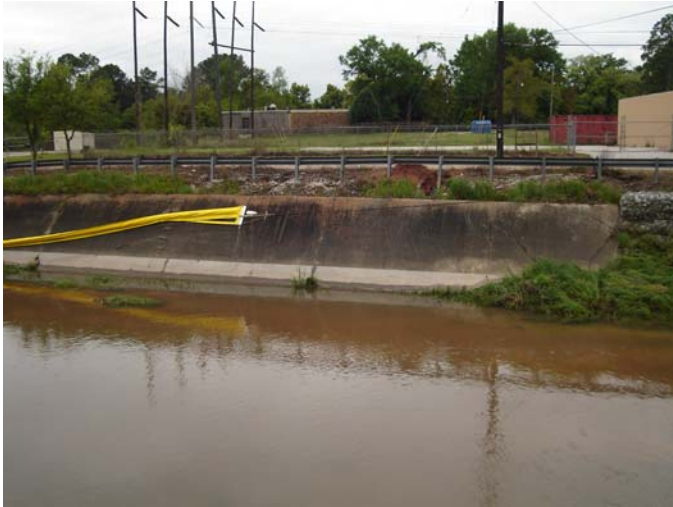
Image 1 shows the raised level of the Eslava side of the boom and the apparent raise in water level.

Through the study, a potential flaw has been identified in the floating boom's installation, as seen in the first image of Figure 3. As previously mentioned, the April 4th and 5th rainfall event saw over 8 inches of rain throughout Mobile. This allowed the stream channel to reach a depth well over the height of the Woodcock Branch anchor. Because of the piling of dead grasses and sediment along the steel cable, it is evident that at the highest point of the flash flood event, the water level was higher than the cable allowed the barrier to move. Therefore, a person can assume that at this edge the barrier was submersed. This could allow some debris to float around the bend along the channel wall, and pass the barrier.

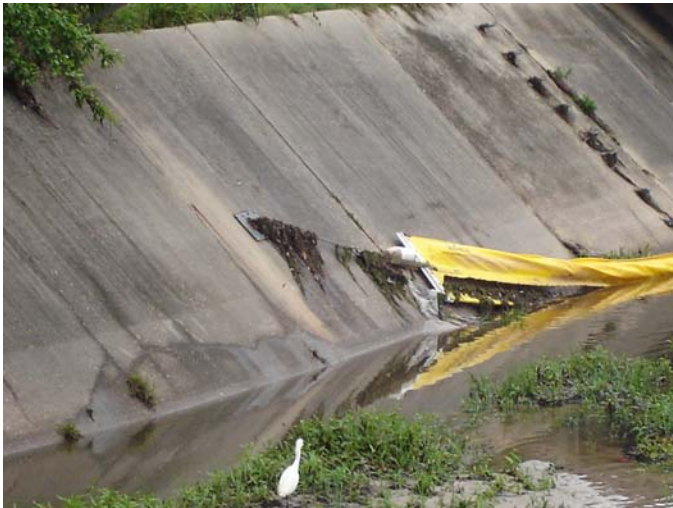
Image 2 shows the Woodcock Branch anchor that is covered by the grasses and debris.

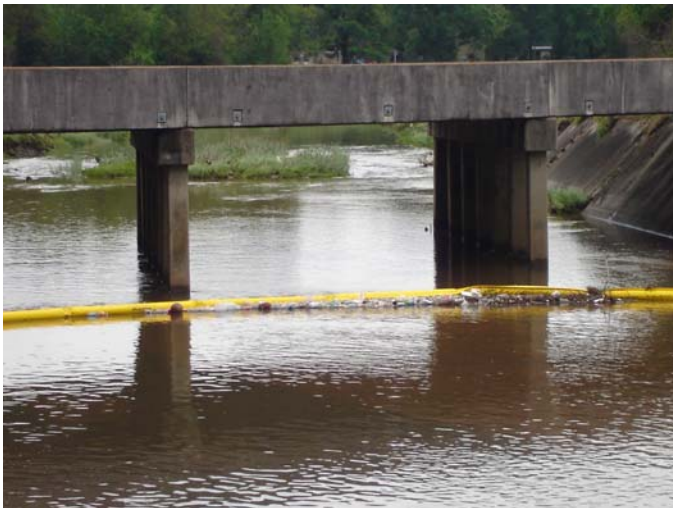
Image 3 shows the debris and garbage amassed in the center of the debris barrier along its bend.

On the fifth, a second trip was taken to the debris barrier to observe its status post-rainfall (Figure 3). Water levels had risen extremely high over the course of the evening. This was evident by watermarks on the concrete channel as well as the extent to which the grass in the channel was pushed over. In the previous visit, the Eslava side of the debris barrier rested along the second steel step from the bottom of the streambed, where as now it rested over a foot higher on the fourth step as seen in the first image of Figure 3. The boom was bowed across the confluence, as the water level was still higher than during the previous visit. Shown in the second image of Figure 3, the anchor on the Woodcock side had grasses covering it and the steel cable. Figure 3 also shows a large pile of debris accumulated in the center of the bow on top of the water and against the barrier. Two other short spans of the barrier collected debris. Along the bank walls and streambed banks there were several places washed clean of trash that was present at the earlier visit.
