A SEARCH FOR THE SOURCE OF SEDIMENT DEPOSITS IN BOLTON BRANCH

Jennifer L. Reynolds, Department of Earth Sciences, University of South Alabama, Mobile, AL 36688. E-mail: jl312@gmail.com.

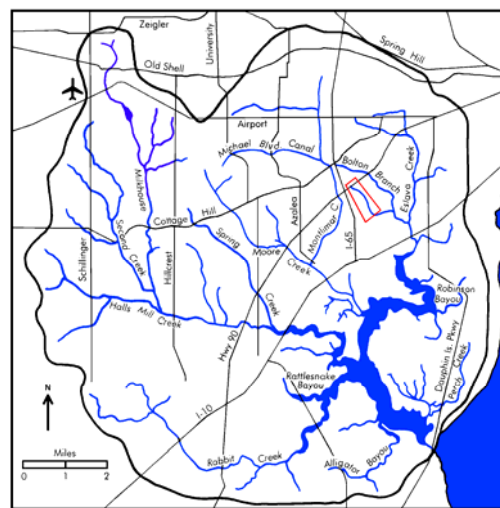
Figure 1: Map of Dog River Watershed, with study site boxed in red.

To begin this project I first chose my study site (Fig. 1). While there are many creeks in the Dog River Watershed showing varying levels of sediment deposition, I decided to focus on Bolton Branch at Halls Mill Road near Satchel Paige Drive (Fig. 2), an area experiencing recent significant sediment buildup. I used a Mobile 7 1/2' quadrangle map and a digital camera to conduct my field research.

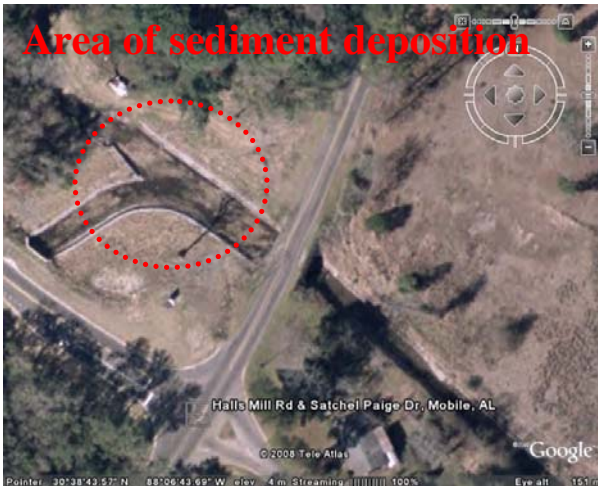
Figure 2: Google Earth image of sediment deposit in Bolton Branch at Halls Mill Road circled in red.

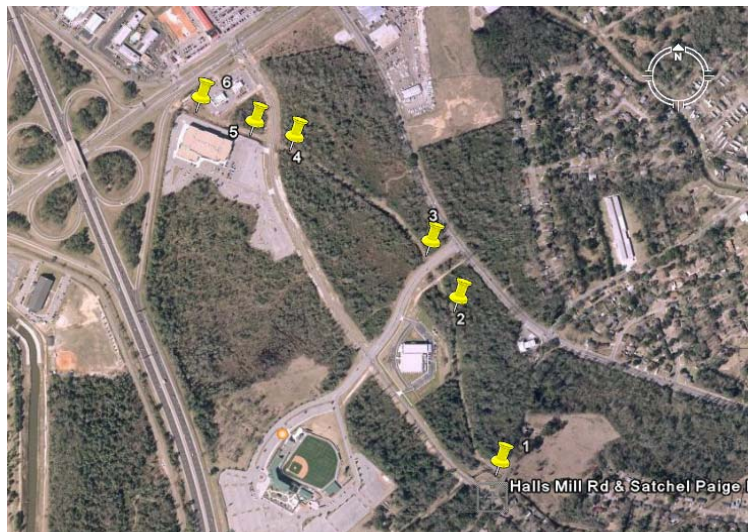
Figure 3: Google Earth image of Bolton Branch, from Highway 90 downstream to location of sediment deposit. Also shows the six study sites used in this research.

has recently been accumulating, in 2001 and April 2008. As I walked upstream from the sediment deposit, I observed slowly flowing water in the stream and lush vegetation along the slopes. Before point 2 on the above map (Fig. 3), I took notice of minimal erosion, and between points 2 and 3 the slopes of the stream had been lined with rocks. The drain which travels underneath Bolling Brothers Boulevard was experiencing a buildup of sand on its entrance and exit from the pipe. Between points 3 and 4, the slope of the creek lessened, the vegetation increased, and I observed

no significant erosion along the banks of the stream. Continuing along the stream after crossing Satchel Paige Drive, I noticed areas of extreme streambank erosion along both sides of the stream, from Satchel Paige Drive to Highway 90, essentially where the stream, and this problem, begins. In some areas, complete sections of soil were sliding

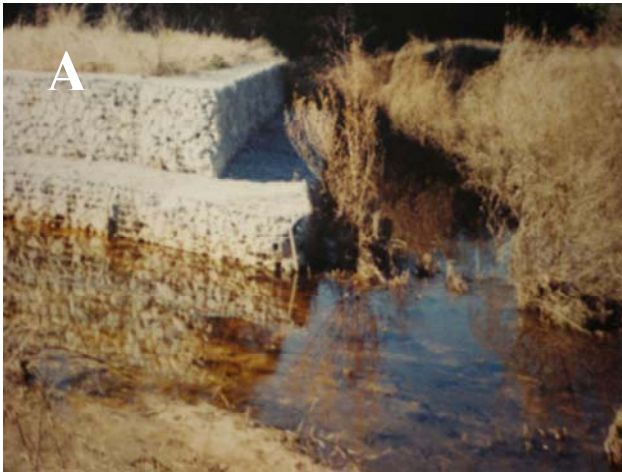
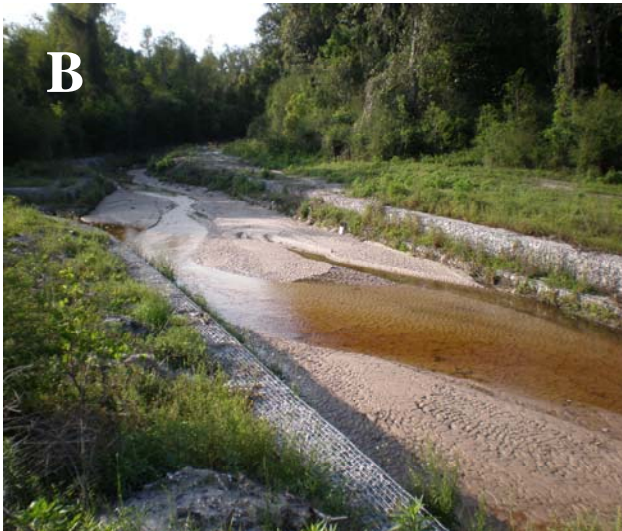
The majority of my results came from the comparison of past and recent photos of my sites along Bolton Branch. Figures 4a and 4b show the location where the sediment

Figure 4a: Bolton Branch at Halls Mills Road in 2001.

Figure 4b: in 2008.

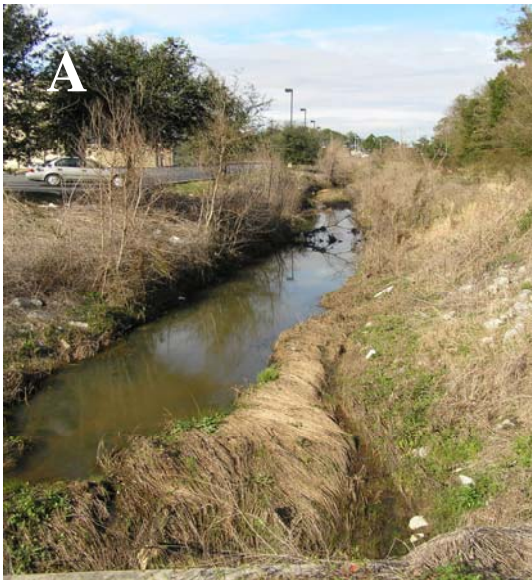
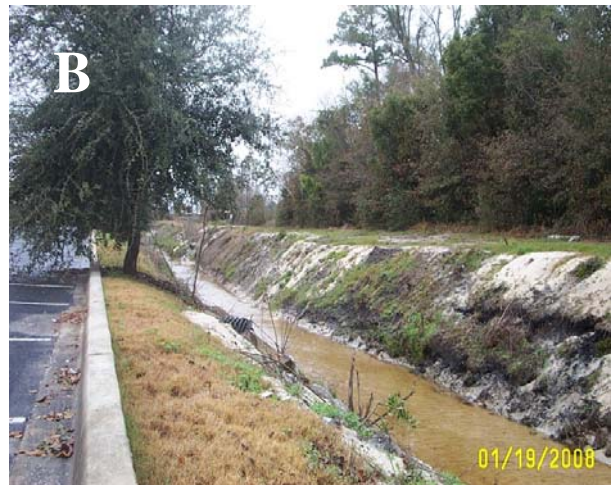
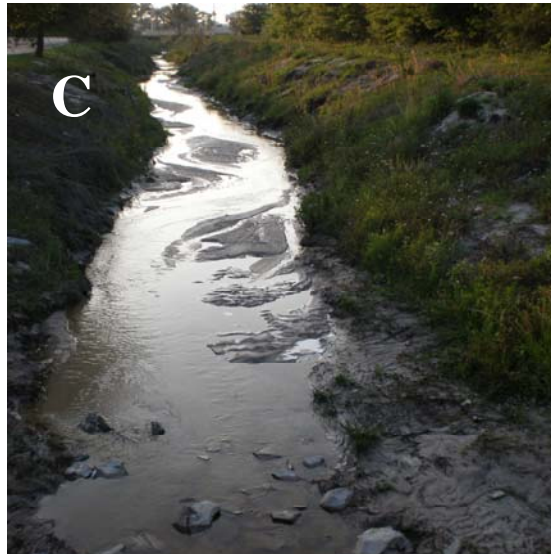
down the slope into the stream. Figures 5a, 5b, and 5c show the same area of the creek, behind Hollywood Theaters on Satchel Paige Drive, at different stages of vegetation along the slopes and banks of the creek's channel. Figure 5a is from January 2007, and shows abundant vegetation within and along the water. Figure 5b is from January 2008, weeks after the city's stream channel "improvements," and Figure 5c is from April 2008, and vegetation can be seen growing back along the banks of the stream.

Figure 5a: Bolton Branch between Satchel Paige Drive and Highway 90, January 2007
Figure 5b: same location, January 2008
Figure 5c: same location, April 2008

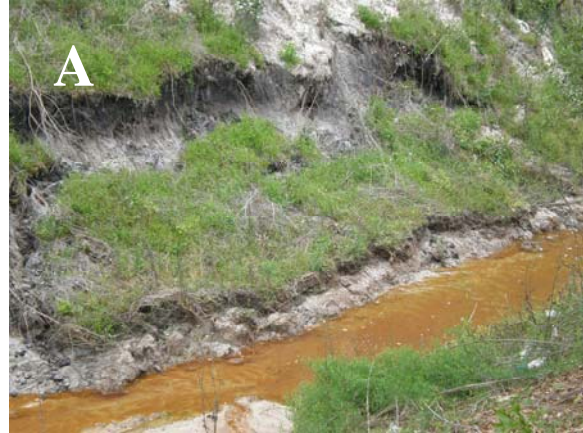
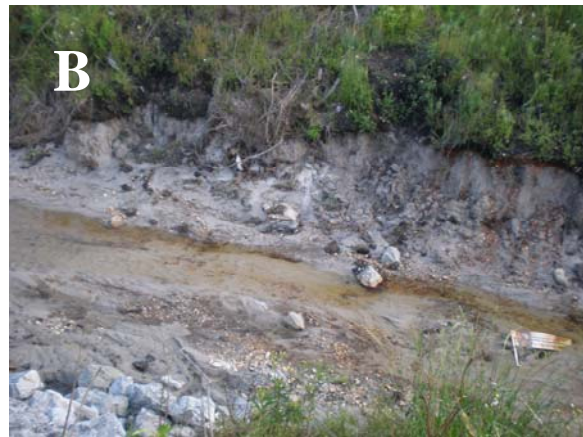
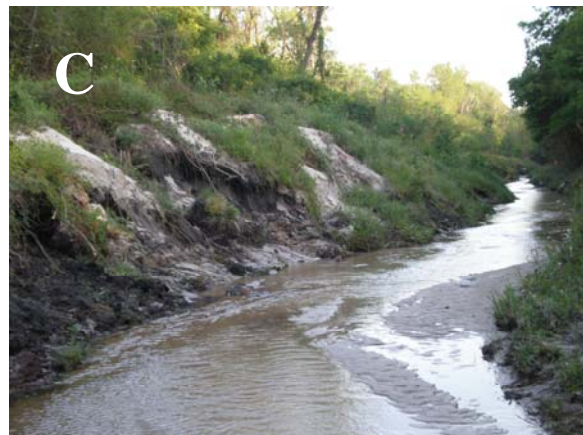
Erosion occurring along the sides of the stream channel is the primary source of the sediment depositing in Bolton Branch. While searching the City of Mobile's website, I came across several proposals during 2007 involving channel improvements. This was one of several, aimed at ultimately improving drainage in Mobile (City of Mobile, 2007). This was done using machinery which removed trash, debris, and important vegetation from the sides and bottom of the creek. By removing the vegetation, they removed the most important factor in stream bank stability, and thus increased the amount of erosion from the sides of the stream into the bottom of it. Figure 6a, 6b, and 6c shows erosion along the sides of the stream. Once we get a significant rain, the sediment from the bottom gets transported downstream, until the velocity of the water weakens

Figure 6a, 6b, 6c: Erosion occurring on the slopes of the stream.

or the weight of the sediment becomes too heavy to carry. It is important to note that

before the sediment pile in Bolton Branch, the channel is not concrete, but changes to a concrete channel shortly after. The slower movement of water in the natural channel compared to the increased movement once it reaches the concrete channel has influenced where the majority of the sediment has deposited, just before the concrete begins.
